Task 13 Performance, Operation and Reliability of Photovoltaic Systems

# Quantification of Technical Risks in PV Power Systems

## 2021

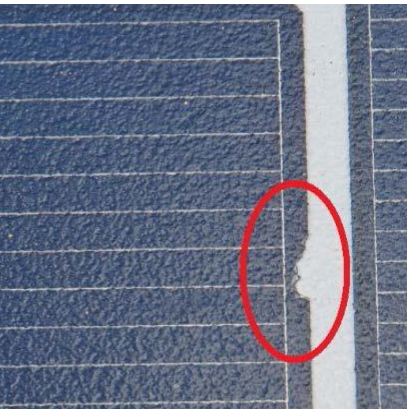
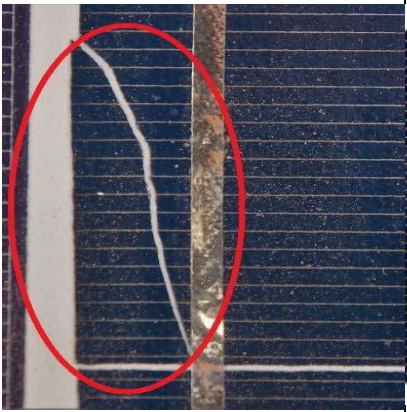
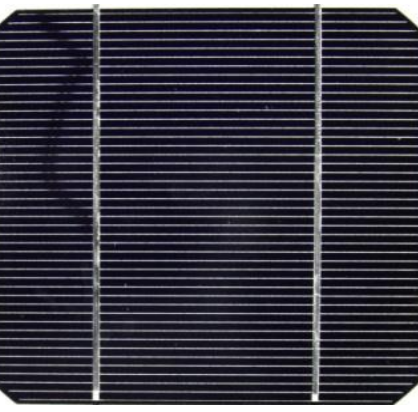
EXAMPLES (page1)		PVFS 1-1vs.01	
Examples 1-3

Cell chipping. A very small region is missing from the edge of the cell, but does not enter metalized region. [16]	Large crack at cell corner visible by eye - small portion of the cell (<10%) is no longer electrically connected. [16]	Cell crack with snail track. No isolation of any cell part. The propagation could isolate a cell area >10%. [16]
Severity

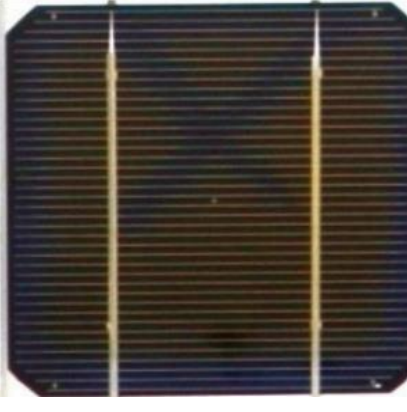
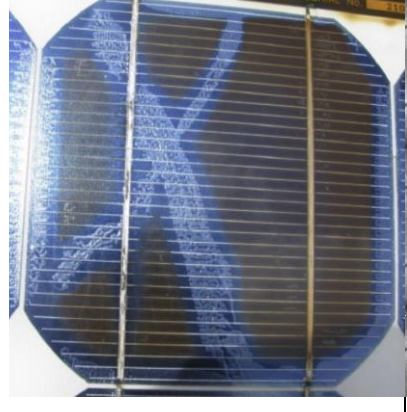
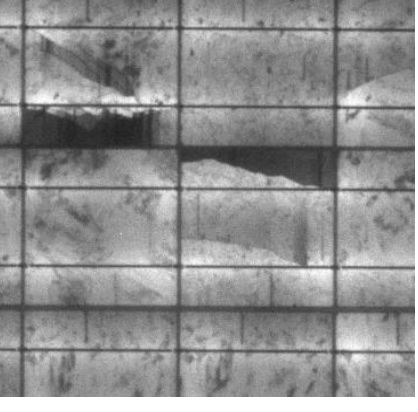
Examples 4-6

Cell cracks visible by the photo-bleaching effect. This may not be mistaken for snail tracks. [16]	Two cell cracks with extensive delamination, EVA browning and photo bleaching. [41]	EL image of 2 cell cracks which isolates more than 10% of the cell area. [TUV Rheinland]
Severity

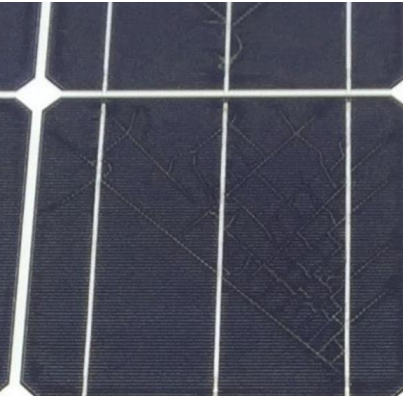
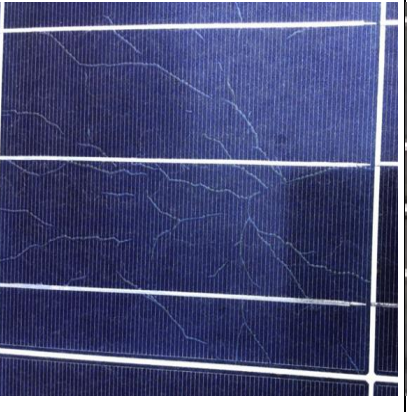
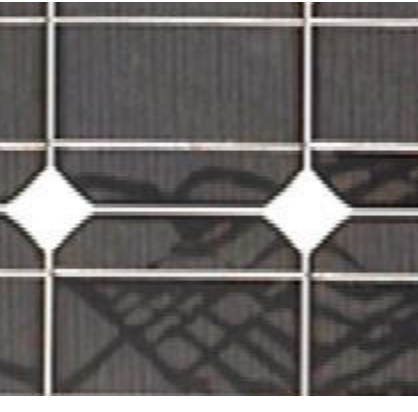
Examples 7-9

Snail track example. [41]	Snail track example. [41]	EL of cell cracks with snail tracks. [16]

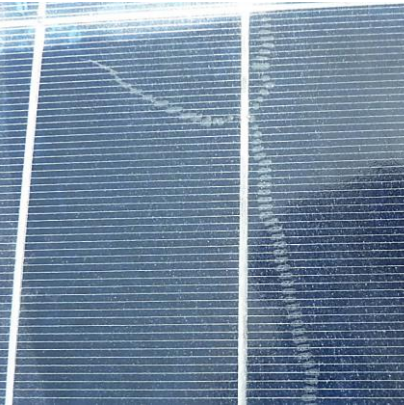
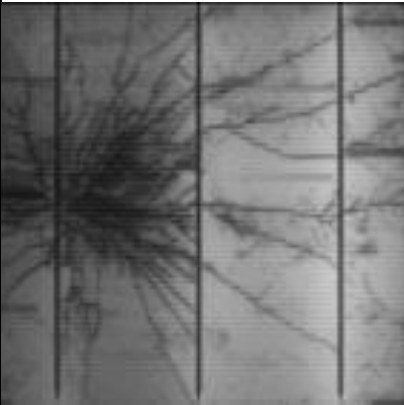
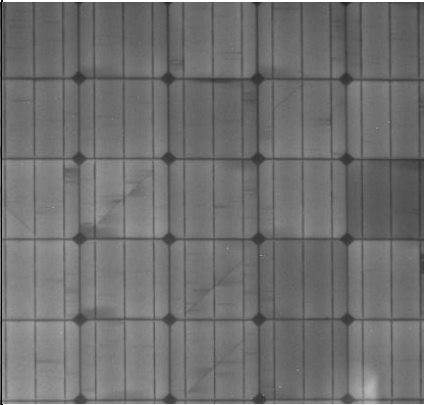
Examples 13-15

Cell crack with EVA delamination. [TUV Rheinland] (see also PVFS 1-3)	Typical EL picture of a cell crack caused by hail. [TUV Rheinland]	Repetitive crack pattern due to impact of soldering machine. [SUPSI]
Severity

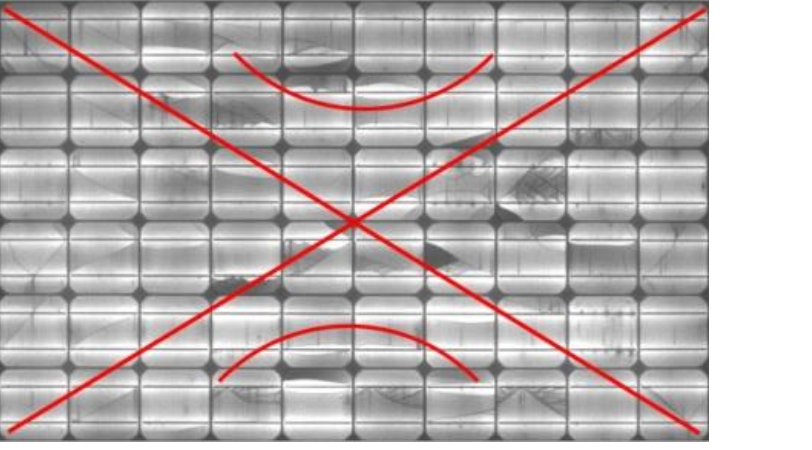
Examples 16

Typical EL picture of cell cracks caused by a heavy homogeneous mechanical load (X-crack pattern) also without glass breakage. [16]		
Severity

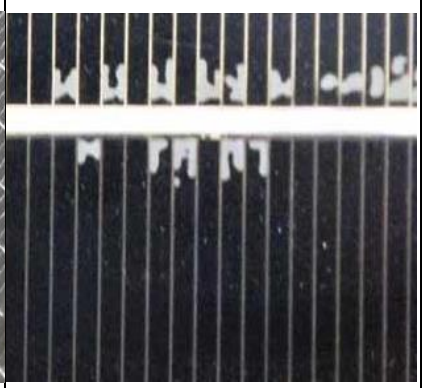
<p>Examples 1-3</p>

<p>Encapsulant delamination in un-critical position. [SUPSI]</p>	<p>Encapsulant delamination from cell caused by production process. [SUPSI]</p>	<p>Encapsulant delamination from cell along grid fingers and bus bar. [38]</p>			
<p>Severity</p>

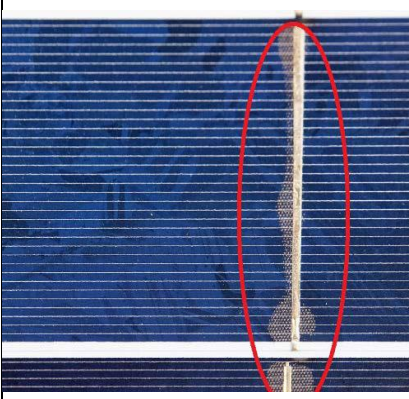
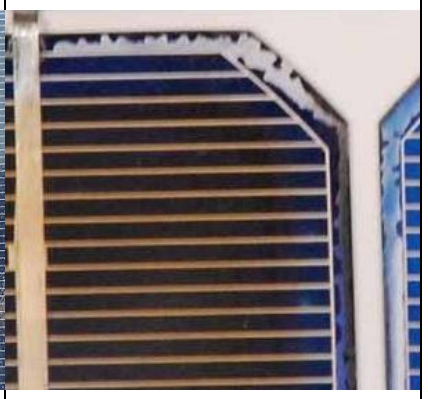
<p>Examples 4-6</p>

<p>Encapsulant delamination from glass (spotted due to glass texture) along the bus bars. [37]</p>	<p>Encapsulant delamination along a cell crack. [46] (see also PVFS 1-1)</p>	<p>Encapsulant delamination near cell edges in combination with cell browning. [38]</p>			
<p>Severity</p>

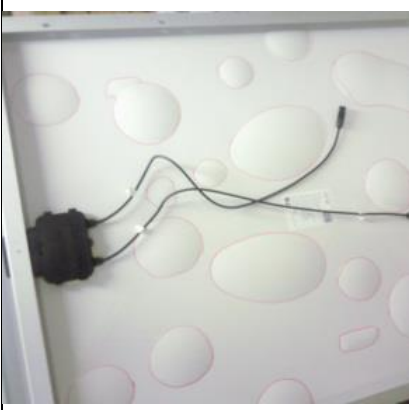
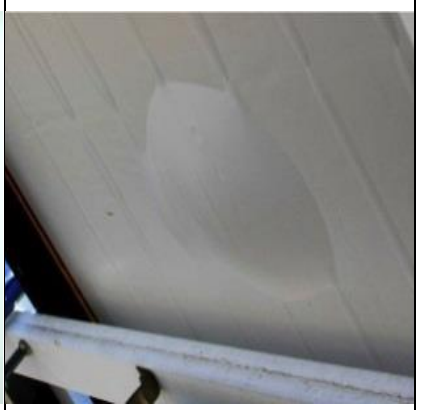
<p>Examples 1-3</p>

<p>Multiple bubbles in the centre and edge of the backsheet. [46]</p>	<p>Blisters because of vapour barrier, such as aluminium foil. [1]</p>	<p>Big central bubble + wavy delamination. [16]</p>			
<p>Severity</p>						
<p>Examples 4-5</p>

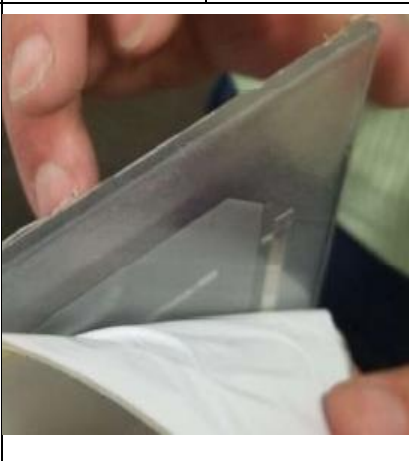
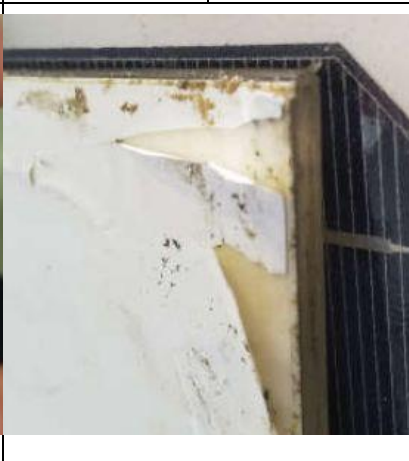
<p>Backsheet delamination with direct exposure of encapsulant. [SUPSI]</p>	<p>Delamination of top layer without exposure of encapsulant. [SUPSI]</p>				
<p>Severity</p>

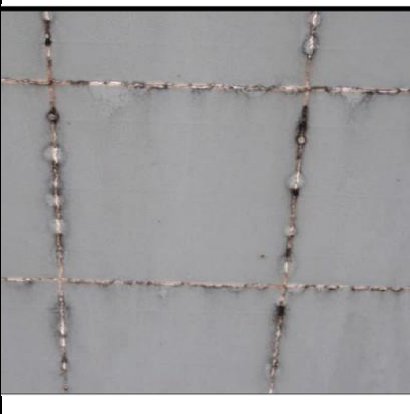
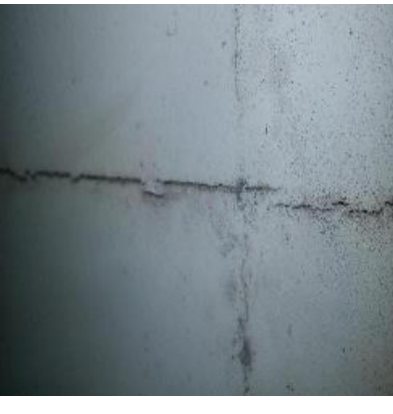
<p>Examples 1-3</p>

<p>Cracked backsheet in combination with yellowing under a hot cell. [39]</p>	<p>Squared cracks beneath cell interspaces. [39]</p>	<p>Cracking between cells. [38]</p>			
<p>Severity</p>

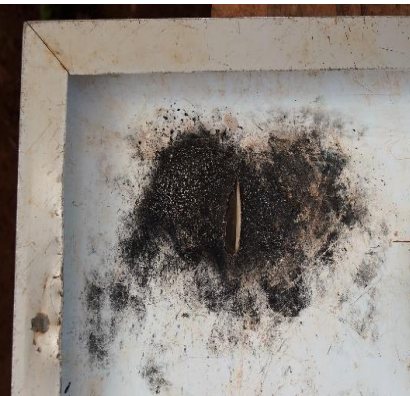
<p>Examples 1-3</p>

<p>Burn mark at the backsheet with cracked backsheet. [37]</p>	<p>Burn marks at the backsheet due to heating along a busbar. [16]</p>	<p>Burn mark associated with overheating along the metallic interconnection (without backsheet damage). [16]</p>
<p>Severity</p>

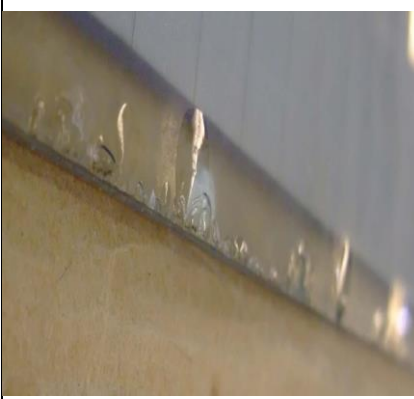
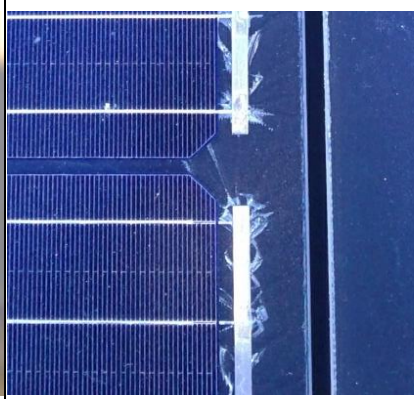
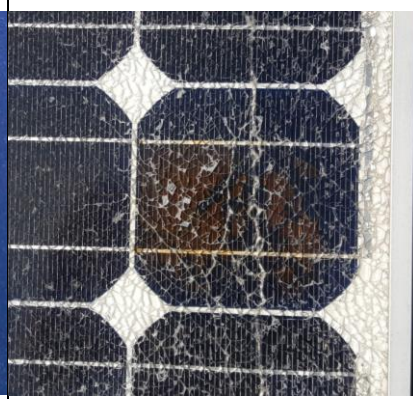
<p>Examples 1-3</p>

<p>Chipped glass at the corner. [38]</p>	<p>Glass breakage along the string interconnect ribbons due to weak manufacturing process. [SUPSI]</p>	<p>Glass breakage of tempered glass induced by a hot-spot. [SUPSI]</p>			
<p>Severity</p>

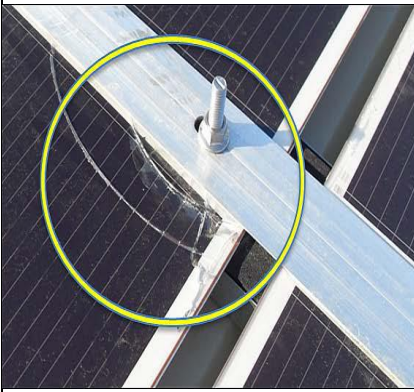
<p>Examples 4-6</p>

<p>Glass breakage caused by too tight screws. [16] (see also PVFS 3-1)</p>	<p>Glass breakage caused due to poor clamp design. [16]</p>	<p>Glass breakage caused due to poor clamp design. [1] (see also PVFS 3-1)</p>			
<p>Severity</p>

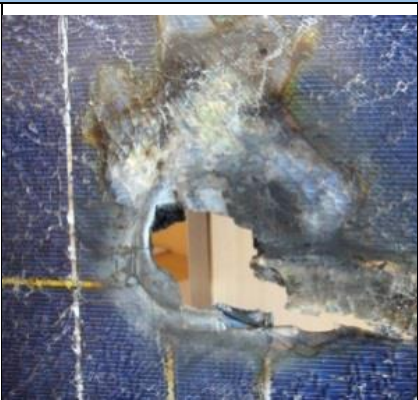
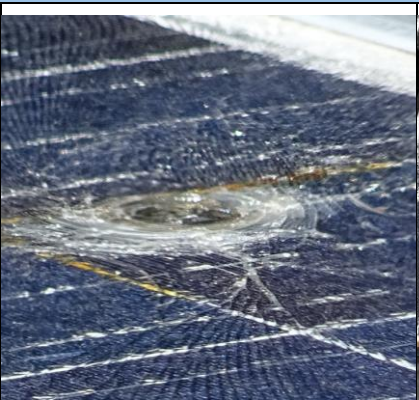
<p>Examples 10-12</p>

<p>Direct lightning stroke. [46]</p>	<p>Impact damage caused by a heavy object. [SUPSI]</p>	<p>Hail damage. [SUPSI]</p>
<p>Severity</p>	<p>f e m  ----- 5</p>	<p>f e m  ----- 5</p>	<p>f e m  ----- 5</p>

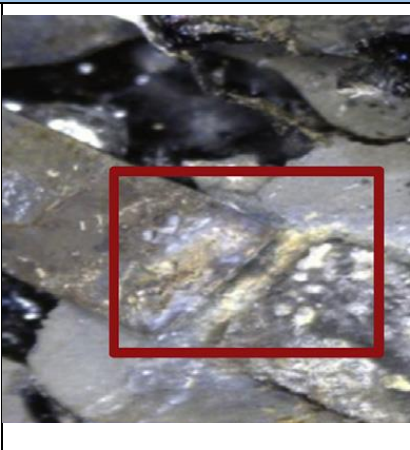
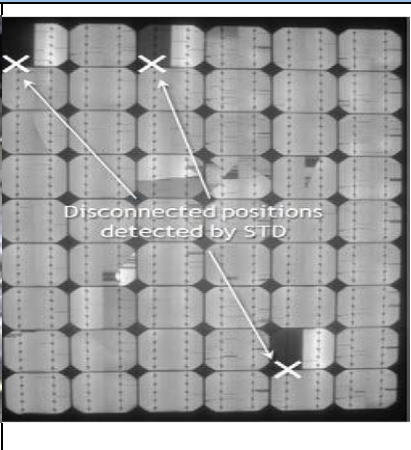
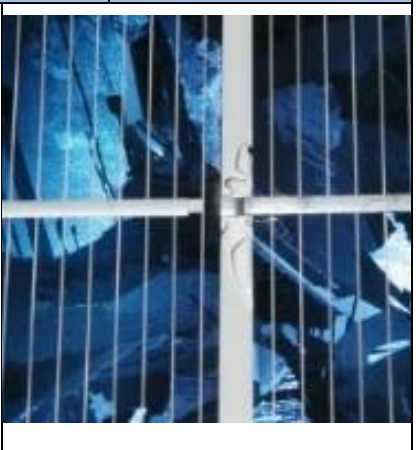
<p>Examples 1-3</p>

<p>Zoom of a broken cell interconnect. [41]</p>	<p>EL image of a module with 3 cells with disconnected interconnect ribbons. [16]</p>	<p>Disconnected cell interconnect with delamination. [1]</p>			
<p>Severity</p>

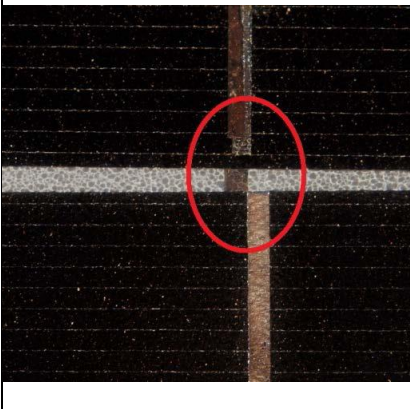
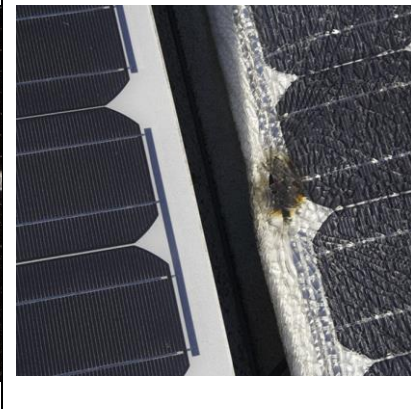
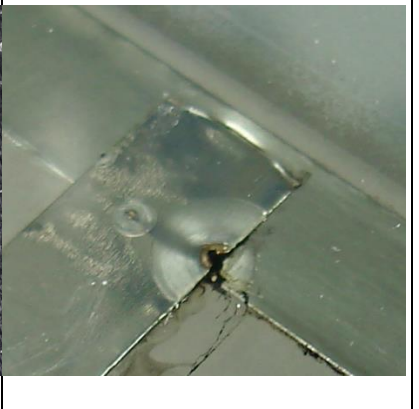
<p>Examples 4-6</p>

<p>Dislocation of interconnection ribbon. [37]</p>	<p>Poor soldering of string interconnect leading to burn mark and broken glass. [41] (see also PVFS 1-7 and PVFS 1-8)</p>	<p>Micro arc which occur if the conductive glue on the string interconnect has an insufficient contact. [16]</p>			
<p>Severity</p>

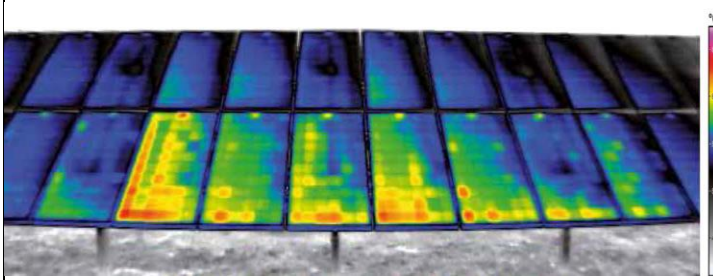
Examples  
1-2

Strings with PID, detected with IR thermography. [16]

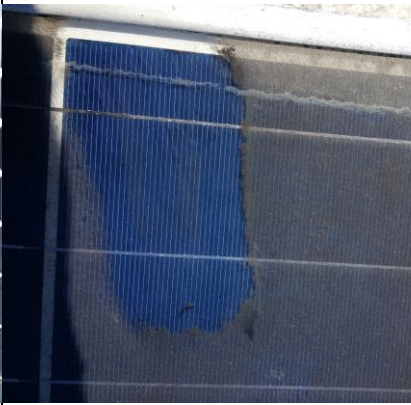
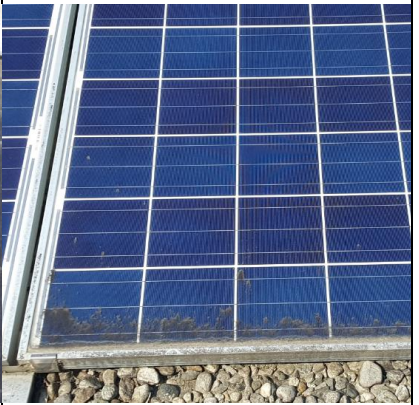
<p>Examples 1-3</p>

<p>Uniform light soiling, which in ideal conditions is self-cleaning when raining.</p>	<p>Uniform heavy soiling caused by rail way station. [SUPSI]</p>	<p>Non-uniform soiling caused by low inclination and close mounting to roof. [SUPSI]</p>
<p>Severity</p>

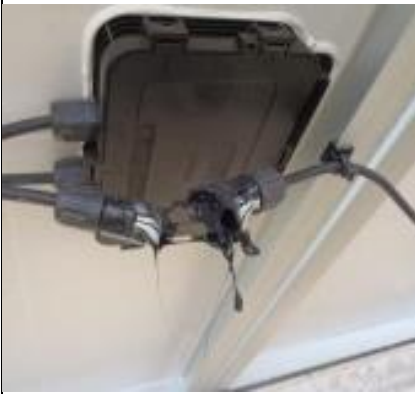
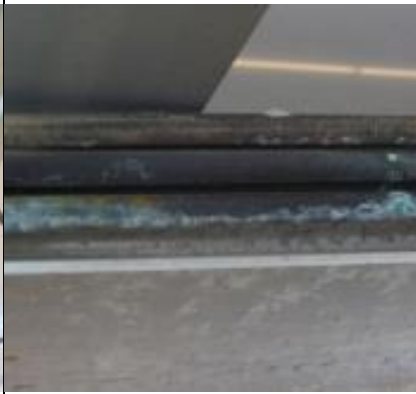
<p>Examples 8-10</p>

<p>Burned connector. [1]</p>	<p>Corroded Cable. [1]</p>	<p>Animal bite on cable. [1]</p>			
<p>Severity</p>

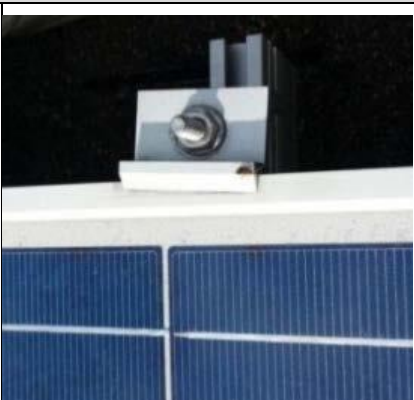
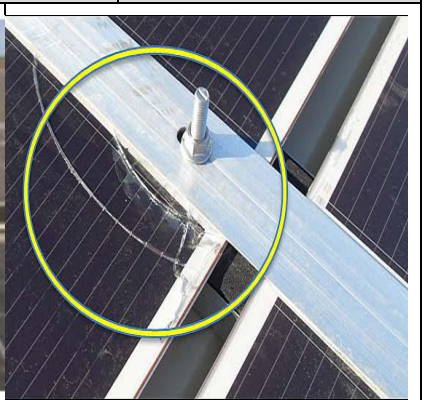
<p>Examples 1-3</p>

<p>Improper installation of clamp. [?]</p>	<p>Wrong combination of clamps and modules. [40]</p>	<p>Glass breakage caused by too tight screws. [35] (see also PVFS 1-8)</p>
<p>Severity</p>

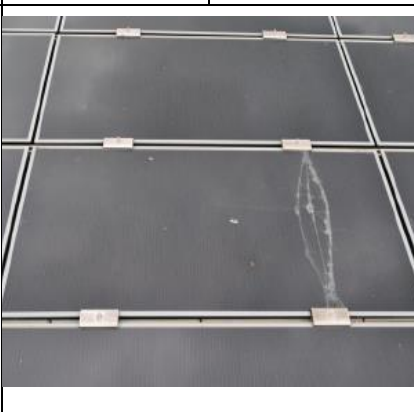
<p>Examples 4</p>

<p>Glass breakage caused by poor clamp design. [40] (see also PVFS 1-8)</p>		
<p>Severity</p>

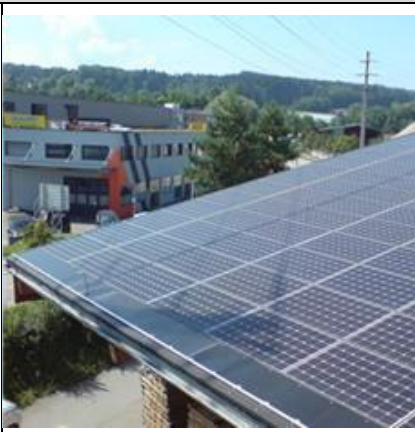
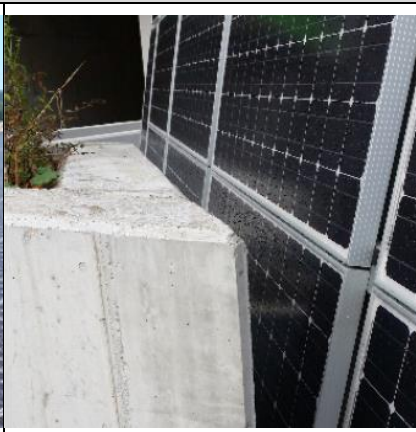
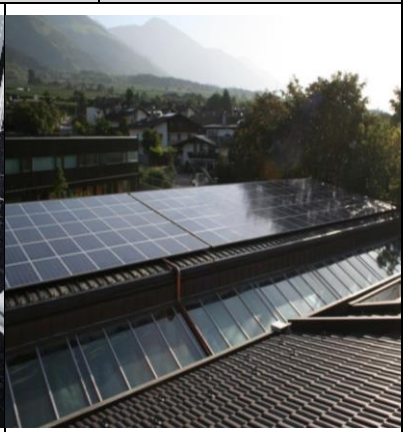
<p>Examples 1-3</p>

<p>Shading by pole-and-wire (poor design: too close to nearby shading objects). [36]</p>	<p>Shading due to bad planning or coverage by afterwards build construction element. [40]</p>	<p>Shading by tree with seasonal changes due to foliage. [40]</p>			
<p>Severity</p>
