Task 13 Performance, Operation and Reliability of Photovoltaic Systems

# Quantification of Technical Risks in PV Power Systems

## 2021

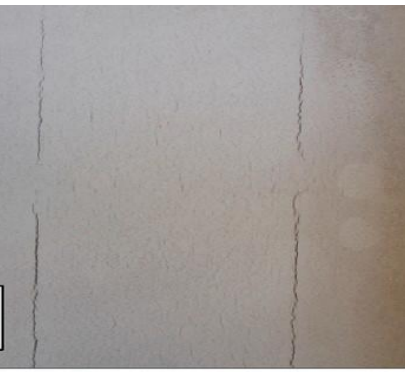
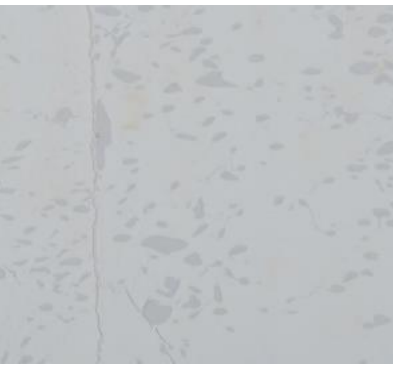
<p>Examples 4-6</p>

<p>Longitudinal cracks located under bus bars. [39]</p>	<p>Backsheet cracking. [57]</p>	<p>Backsheet cracking. [57]</p>			
<p>Severity</p>

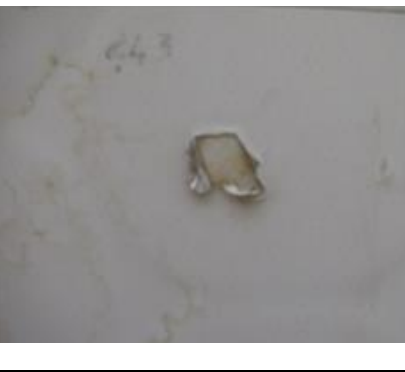
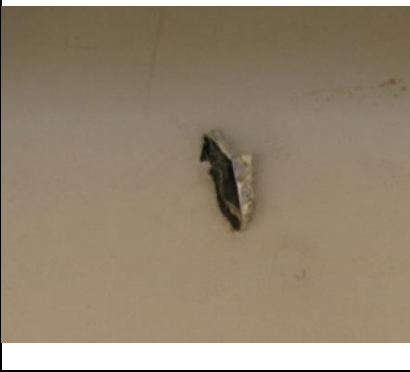
<p>Examples 7-8</p>

<p>Localized superficial damage. [1]</p>	<p>Deep scratch on backsheet. [TUV Rheinland]</p>				
<p>Severity</p>

Component Defect	Module Backsheet chalking (whitening)		PVFS 1-6vs.01
Appearance	White powder is detectable on the external surface of the backsheet. It can be seen by passing a finger over the backsheet. It can be removed. The backsheet has usually a rough or dull appearance.		
Detection	VI		
Origin	Chalking is caused by the photothermal degradation of the polymers in the outer backsheet layer containing inorganic pigments. For example, TiO <sub>2</sub> pigments are often used in the outer layers as UV blocker.		
	Production <input checked="" type="checkbox"/>	Installation <input type="checkbox"/>	Operation <input checked="" type="checkbox"/>
Impact	Chalking does not affect module safety or performance on first sight, but it can be a sign for an ongoing degradation of the backsheet and a precursor for severe backsheet cracking. Due to the degradation-induced reduction of UV protection, more serious failures, such as <b>backsheet cracking</b> and <b>insulation failures can occur</b> . Enhanced moisture diffusion into the encapsulant/active PV-parts can lead to <b>corrosion</b> of cells and connectors, having a negative impact also on the performance.

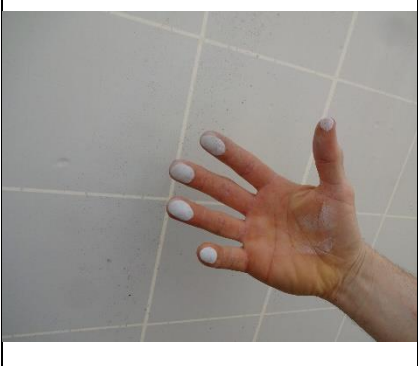
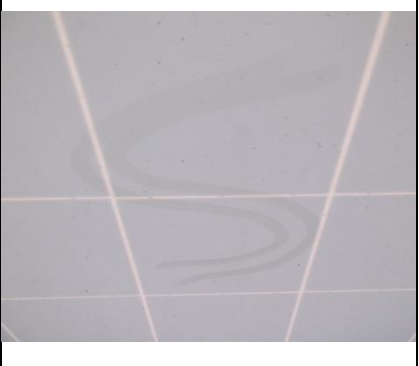
<p>Examples 1-2</p>

<p>Finger with white powder. [TUV Rheinland]</p>	<p>Fingerprint on a module with chalking. [TUV Rheinland]</p>				
<p>Severity</p>

Mitigation	Corrective actions	Preventive actions (recommended)	Preventive actions (optional)
	Regular inspections should be done to monitor the progress of the observed failure. Ground fault detection by inverter or other devices at all time.	Check validity of IEC 61215 certification and BOM.	Regular system inspections.

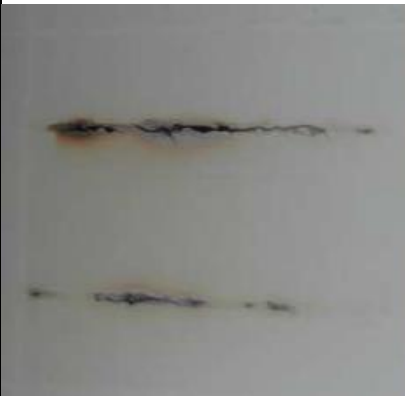
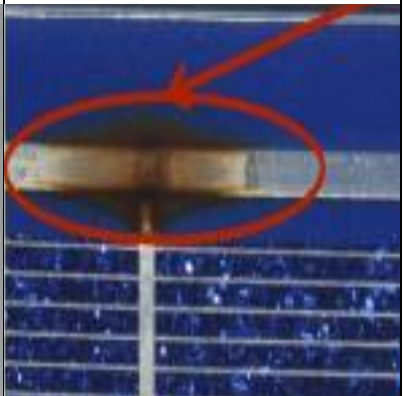
<p>Examples 1-3</p>

Component Defect	Module	PVFS 1-7 vs.01	
Appearance	Burn marks are visible with the naked eye as burnt, blackened area/s. The burn mark may lead to bubbling or melting of the polymeric encapsulant, and/or glass breakage or a hole in the backsheet. Burn marks on the backsheet may be not visible from the front requiring an inspection with an IR camera if the back of the module is not accessible. They may however not be visible by IR inspection in case no further or ongoing heating occurs.		
Detection	VI, IRT, (EL)		
Origin	The defect is associated with parts of the module that became very hot because of production errors (e.g weak solder bonds, ribbon breakage, incomplete cell edge isolation, alignment errors, metal particles) and/or transportation/handling errors (e.g, <b>cracked cells, damaged back-sheet</b> ) in combination with one or more operational factors (e.g. shadowing, <b>open circuited bypass diodes</b> , reverse current flows). Physical stress during PV module transportation, heavy snow loads, a lightning strike, thermal cycling, and/or <b>hot spots</b> by partial cell shading during long-term PV system operation forces mechanical weak(ended) cell/connection parts to break. Burn marks occur for example when a reverse current flow causes heating that further localizes the current flow, leading to a thermal runaway effect and the associated burn mark.

<p>Burn mark at the backsheet with cracked backsheet. [37]</p>	<p>Burn marks at the backsheet due to heating along a busbar. [16]</p>	<p>Burn mark associated with overheating along the metallic interconnection (without backsheet damage). [16]</p>
<p>Severity</p>

Safety:		Performance:
Mitigation	Corrective actions	Preventive actions (recommended)	Preventive actions (optional)
	<b>Modules with a direct safety risk or a severity of 5 should be replaced.</b> Regular inspections should be done to monitor the status of the not replaced modules.	Visual inspection before installation, commissioning of system with IRT.	Regular system inspections.

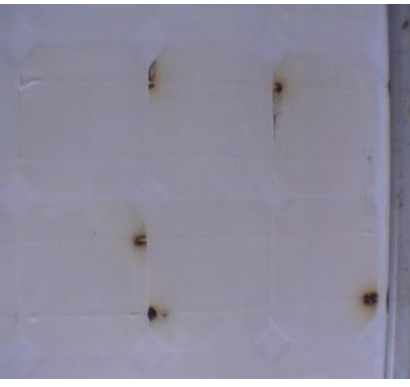
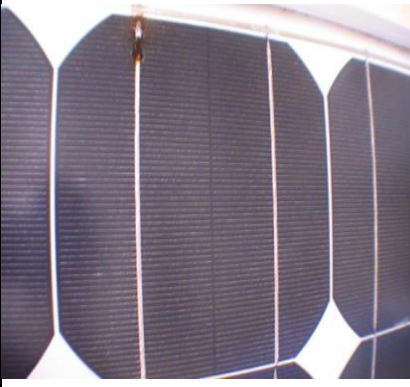
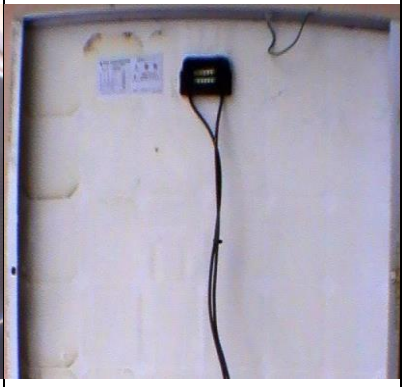
<p>Examples 4-6</p>

<p>Front and back side view of burn marks caused by open-circuited bypass diodes and current mismatch conditions (due to shading or cracked cells). [16]</p>		<p>Burn marks caused by defect bypass diodes or an interconnect failure in the junction box. [16]</p>
<p>Severity</p>

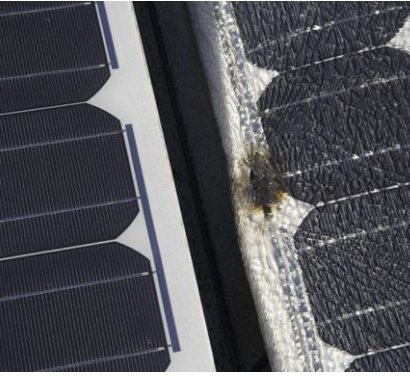
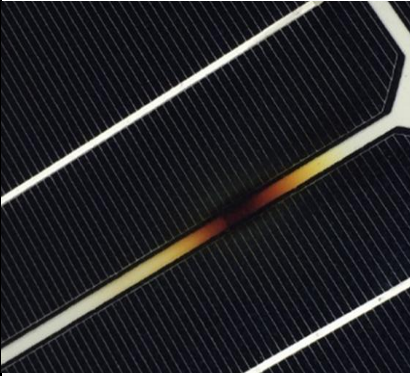
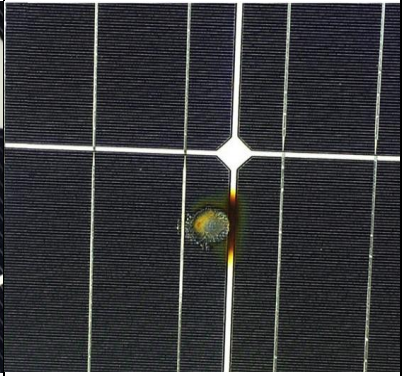
<p>Examples 7-9</p>

<p>Burn mark with broken glass caused by poor bussing ribbon soldering. [41] (s. also PVFS 1-8 and PVFS 1-8)</p>	<p>Burn mark due to intrinsic shunting caused by error in manufacturing process. [41]</p>	<p>Burn mark due to intrinsic shunting caused by error in manufacturing process. [41]</p>

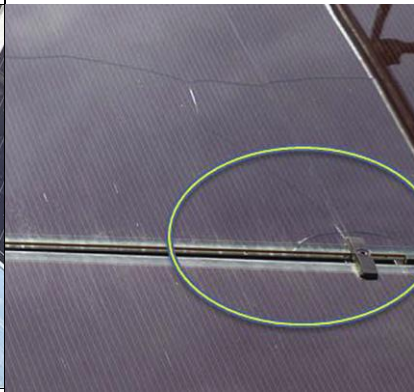
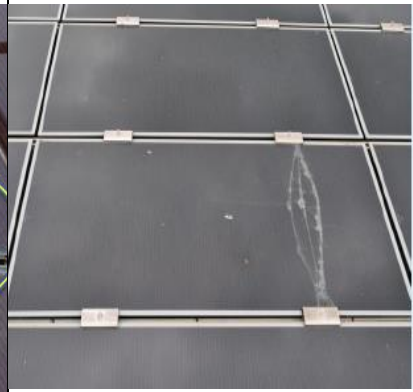
<p>Examples 4-6</p>

Component Defect	Module	PVFS 1-8vs.01	
Appearance	Glass is cracked locally or over the full area of the module. Glass breakage looks different depending on the type of glass and the origin of the glass breakage. Tempered glass or heat-treated float glass will shatter into small pieces, whereas annealed glass breaks into big pieces. Heat-treated glass stays in between.		
Detection	VI, IRT		
Origin	Glass breakages of the front glass can be caused by heavy impacts such as hail or stones or other extreme mechanical stress onto the module frame due to external stresses or bad mounting. High temperatures ( <b>hot-spot</b> or <b>arc</b> ) can also break the glass. Annealed glass breaks also due thermal gradients or stress induced by the lamination process or cleaning of the modules. A relatively often seen failure in the field is glass breakage of frameless PV modules caused by the clamps. Glass/glass modules are more sensitive to glass breakage. The origin of the failure is, on the one hand, at the planning and installation stage either (a) poor clamp geometry for the module, e.g. sharp edges, (b) too short and too narrow clamps or (c) the positions, kind or number of the clamps on the module not being chosen in accordance with the manufacturer's manual. The second origin which induces glass breakage could be excessively-tightened screws during the mounting phase or badly-positioned clamps. The glass of some PV modules may also break due to vibrations and shocks occurring during transportation or handling. Another reason for glass breakage comes from impact stresses on the glass edge. Sometimes vandalism or animal damage happens, the animals like goats like to climb on the PV modules, and birds may drop stone or other objects from the sky.

<p>Glass breakage caused by too tight screws. [16] (see also PVFS 3-1)</p>	<p>Glass breakage caused due to poor clamp design. [16]</p>	<p>Glass breakage caused due to poor clamp design. [1] (see also PVFS 3-1)</p>			
<p>Severity</p>

<b>All damaged modules have to be replaced.</b>	Adequate transport procedures, installation and cleaning by trained personal, in case of higher snow or hail loads use of certified modules.	Regular system inspections.

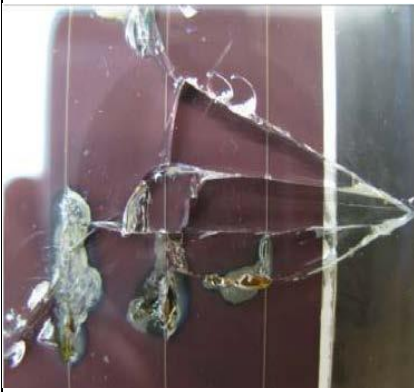
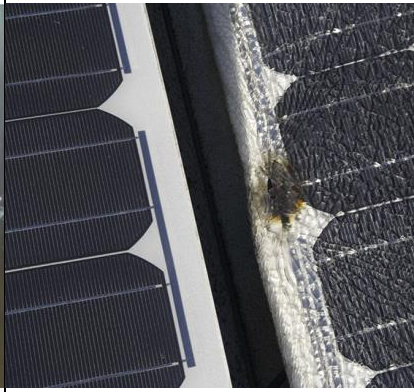
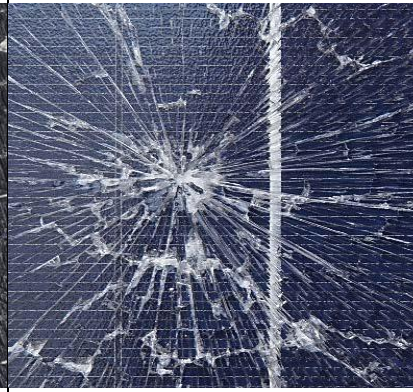
<p>Examples 7-9</p>

<p>Glass breakage through high temperature gradient and not tempered glass. [16]</p>	<p>Glass breakage of tempered glass induced by burn mark. [1] (see also PVFS 1-7 and PVFS 1-9)</p>	<p>Breakage of tempered glass. [1]</p>			
<p>Severity</p>

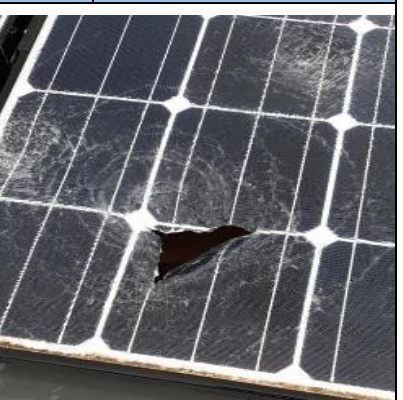
<p>Examples 10-12</p>

<p>Direct lightning stroke. [46]</p>	<p>Impact damage caused by a heavy object. [SUPSI]</p>	<p>Hail damage. [SUPSI]</p>
<p>Severity</p>	<p>f e m  ----- 5</p>	<p>f e m  ----- 5</p>	<p>f e m  ----- 5</p>

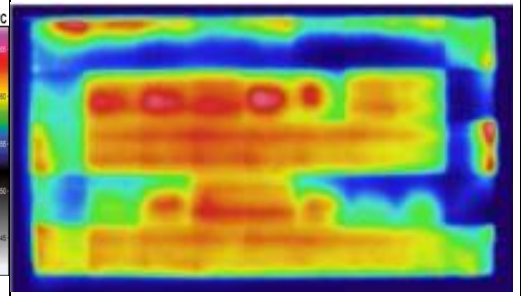
Detection	IV, EL, IRT, (MON)	
Origin	<p>PID is a degradation mode induced by a high voltage stress with respect to ground. The occurrence of this failure depends on the magnitude of the voltage (number of serially connected PV modules per string) and the polarity of the electrical field build-up between the framing/glass surface and the solar cells. The last depends on the inverter typology (transformer), the grounding concept and cell technology. Modules with p-type cells degrade in negative polarity strings whereas modules with n-type cells in strings with positive polarity. PID degradation is more pronounced the higher the potential to which a single cell within a module or string is subjected. The PID effect is therefore stronger in cells that are located at the edges of the module (close to frame) and to the bottom of a string with an increase towards one end of the string. The degradation is further accelerated by temperature, humidity, rain (surface wetting), condensation and soiling. Two different types of PID are known for crystalline silicon modules: PID-p (polarization) and PID-s (shunting). The PID-p was observed for the first time in back contact cells within Sunpower modules. PID-p is caused by the build-up of negative surface charges on the cells, which results in a current loss. The PID-s is induced by leakage currents through the module's front glass and the encapsulation material. The flow of Na<sup>+</sup> ions mainly from the glass into the cell leads to the creations of shunts. For both PID types, module and cell design has a fundamental influence if and how much a module is affected by PID. There are modules on the market which are designed to be PID resistant.</p>

Dark IR thermography at I<sub>sc</sub> for a module affected by PID. [16]

Component Defect	<b>Module</b> <b>Potential induced degradation (PID) (page2)</b>		<b>PVFS 1-10vs.01</b>
Mitigation	<p>Corrective actions</p> <p>How to proceed depends very much on the stage on which PID is detected. If detected in an early stage recovery is possible by applying a reverse voltage during night-time. Specific anti PID kits are available on the market promising a recovery of the lost power. As there is not a full guarantee that the recovery will be effective for the specific situation, it should be monitored or measured to see if the problem has been sufficiently solved. In the case of progressed PID without visible module damages, the recovery could need several months or even years suggesting in any case a replacement of all modules with modules tested to be PID resistant.</p>	<p>Preventive actions (recommended)</p> <p>Modules tested for PID accord. IEC 62804-1 should be less prone to PID (verify that BOM corresponds!)</p>	<p>Preventive actions (optional)</p> <p>PID prevention at system level: The installation of an inverter with transformer can be considered as mitigation measure for the PID phenomenon. On the other hand, the trade-off with the inverter efficiency and the cost of the inverter must be taken into account. Anti-PID insurance.</p>

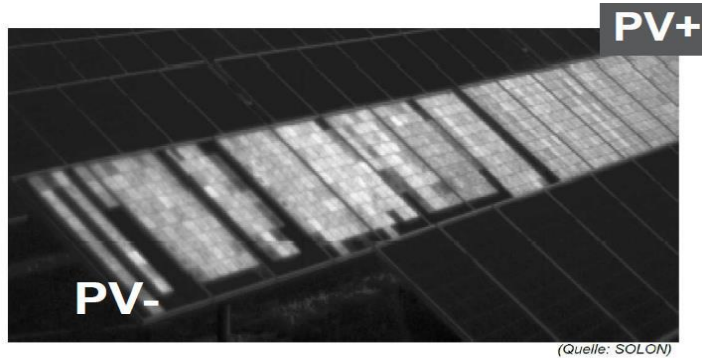
Examples  
3-4

Strings with PID, detected with EL imaging.

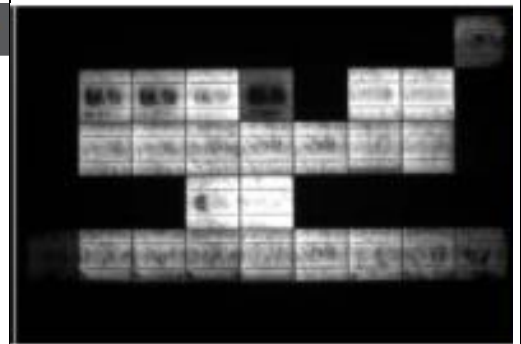
Electroluminescence image made at I<sub>sc</sub> for a module affected by PID. [16]

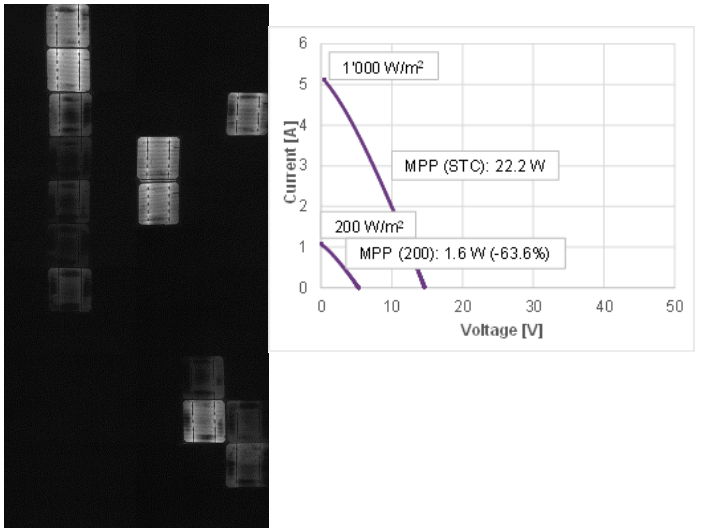
Examples  
5-6

PID affected module with power loss of 89%, left: EL at 1.5 x I<sub>sc</sub>, right: I-V curve of the same module at 1000 and 200 W/m<sup>2</sup>. [35]

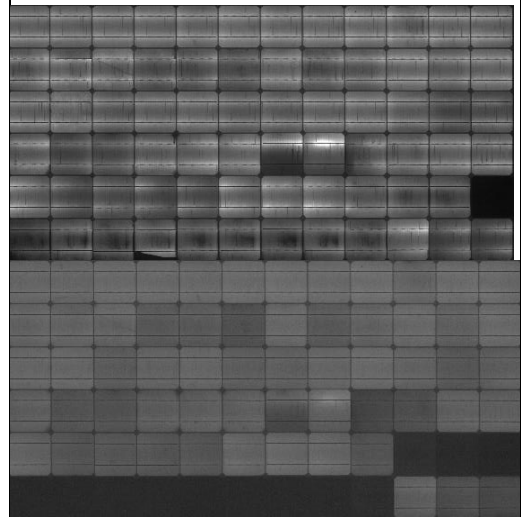
PID affected module with power loss of 14%. top: EL at 1.5 x I<sub>sc</sub>. bottom: EL of the same module at 0.2 x I<sub>sc</sub>. [35]

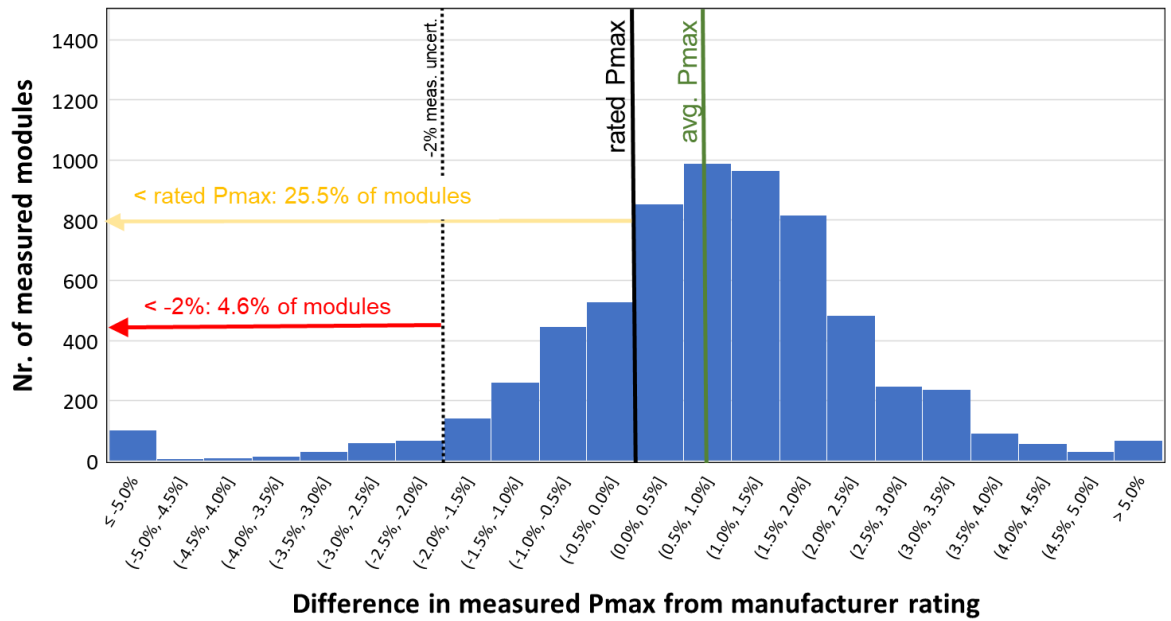
Examples  
2

Statistical analysis done by Eternalsun on around 6500 new modules with 96 different PV module types from 29 different manufacturers. [35] Considering the measurement uncertainty of +/-2% a total of 4.6% of the modules are below the gate 1 limit defined by the IEC 61215 standard. [IEC 61215-1:2021]

*Note: In case of a measurement uncertainty of +/-5% none of the PV modules would fail, but it would be not conform to the IEC 61215 standard prescribing a maximum measurement uncertainty for c-Si modules of +/-3%.*

Mitigation	Corrective actions	Preventive actions (recommended)	Preventive actions (optional)
	Confirm underperformance through an accredited PV test laboratory. Claim for missing power.	Verify power warranties and data sheet conformity, purchase modules from trusted manufacturers.	Independent third party testing of samples at factory gate and/or arrival on site. Signature of a contractual agreements.

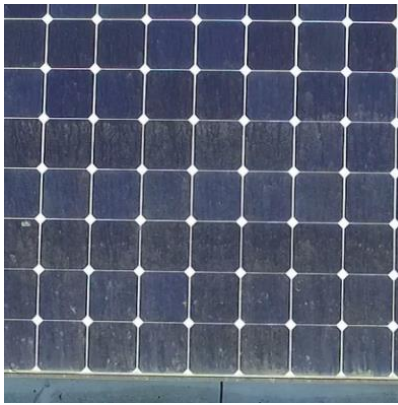
<p>Examples 1-3</p>

<p>Uniform light soiling, which in ideal conditions is self-cleaning when raining.</p>	<p>Uniform heavy soiling caused by rail way station. [SUPSI]</p>	<p>Non-uniform soiling caused by low inclination and close mounting to roof. [SUPSI]</p>
<p>Severity</p>

Performance:
Mitigation	Corrective actions	Preventive actions (recommended)	Preventive actions (optional)
	Cleaning by qualified persons is recommended when the revenue lost because of the missed energy production is higher than the cleaning cost. A best time to clean should be defined.	Preliminary site inspections for the assessment of the soiling risk. Cost estimation for the implementation of mitigation measures. Regular visual inspections to control the soiling level.	Estimation or measurement of soiling losses prior to installation. Installation of soiling sensors to determine the most profitable time to clean.

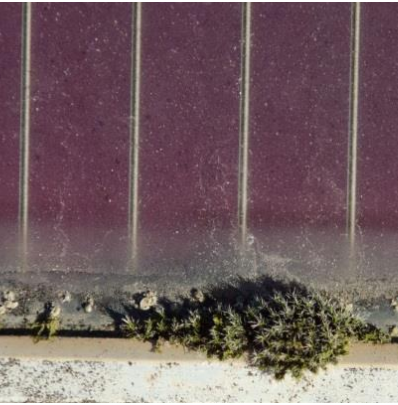
<p>Moss growing on the edge of a module combined with edge soiling. [1]</p>	<p>Soiling pattern on a system in the Atacama desert. [ISE]</p>	<p>Soiling pattern demonstrating dominant wind direction on a test site in Atacama desert. [ISE]</p>
<p>Severity</p>

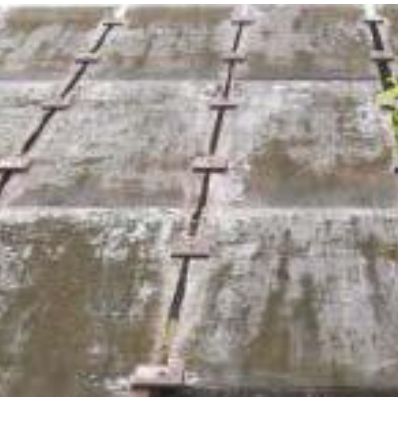
<p>Examples 7</p>

<p>Heavy biofilm soiling. [46]</p>		
<p>Severity</p>

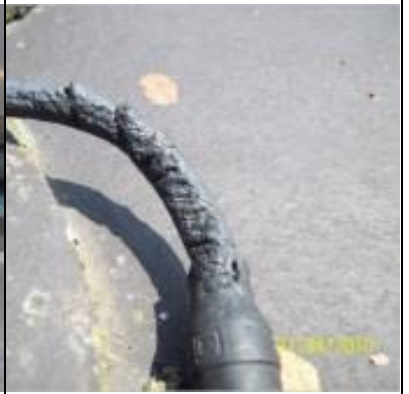
<p>Examples 8-10</p>

<p>Burned connector. [1]</p>	<p>Corroded Cable. [1]</p>	<p>Animal bite on cable. [1]</p>			
<p>Severity</p>

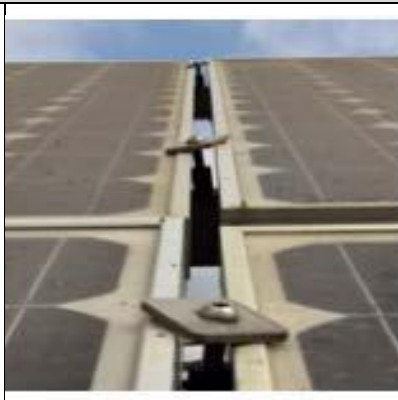
<p>Examples 1-3</p>

<p>Improper installation of clamp. [?]</p>	<p>Wrong combination of clamps and modules. [40]</p>	<p>Glass breakage caused by too tight screws. [35] (see also PVFS 1-8)</p>
<p>Severity</p>

Safety:		Performance:		
Mitigation	Corrective actions	Preventive actions (recommended)		Preventive actions (optional)	
	<b>Modules with a safety risk or a severity of 5 should be replaced.</b>	Use only compatible clamps (mounting structure/ modules/ clamps) and follow manufacturer mounting instructions. Check local wind and snow loads.		Testing of non-standard mounting configurations by an accredited test laboratory (eg. facade mounting), perform regular system inspections

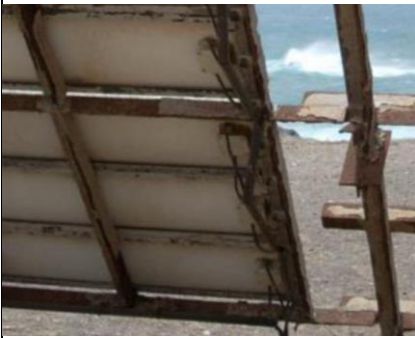
<p>Examples 1-3</p>

<p>Corrosion due to salt water. [46]</p>	<p>Cracks in mounting structure due to mechanical stress. [46]</p>	<p>Screw canal bends due to mechanical stress. [46]</p>			
<p>Severity</p>

Mitigation	Corrective actions	Preventive actions (recommended)	Preventive actions (optional)
	<b>Mounting structures with a direct safety risk should be replaced or repaired.</b>	Use only compatible mounting structures (ground/mounting structure/modules) and follow manufacturer mounting instructions. Check local load (conditions (wind, snow, other)).	Regular system inspections. Testing of non-standard mounting configurations by an accredited test laboratory (e.g. facade mounting), perform regular system inspections.

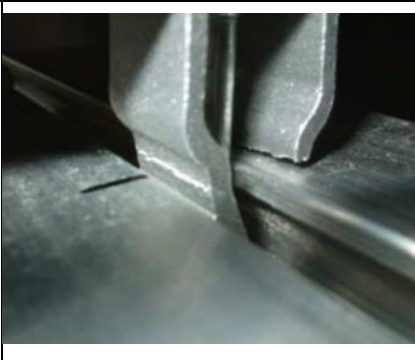
<p>Examples 4-6</p>

<p>Bracket fractured due to mechanical stress. [46]</p>	<p>Undersized mounting structure for local snow load conditions. [46]</p>	<p>Undersized mounting structure for local wind conditions. [15]</p>			
<p>Severity</p>

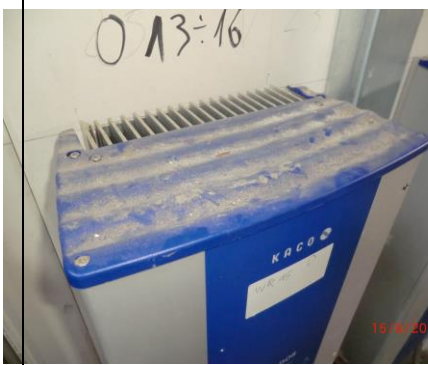
Examples  
1-3

Dust blocking heat dissipation [TUV Rheinland]

Action	Corrective actions	Preventive actions (recommended)	Preventive actions (optional)	
	Once identified the origin of the temperature derating the failure should be repaired. The filters and in general heat dissipation path should be cleared of obstruction.	Follow the given installation procedure, use of adequate cooling technology, perform regular inspections of the ventilation units.	Monitoring of inverter temperature

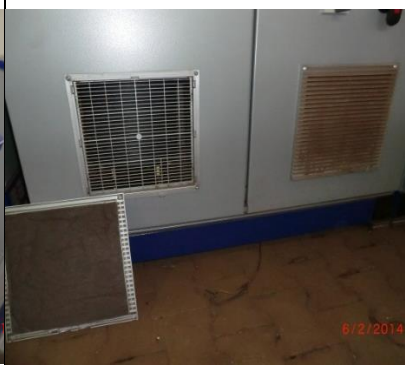
A soiled air filter causes over-heating [TUV Rheinland]

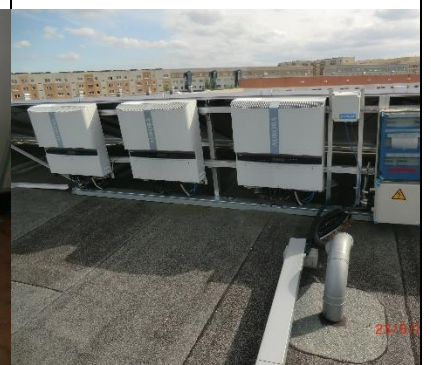
Installation not appropriate (direct exposition to sun) [TUV Rheinland]

Action	Corrective actions	Preventive actions (recommended)		Preventive actions (optional)
	Dismount the component and follow the installation procedure.	Follow the given installation procedure, use of adequate cooling technology, perform regular inspections of the ventilation units.		Monitoring of inverter temperature.

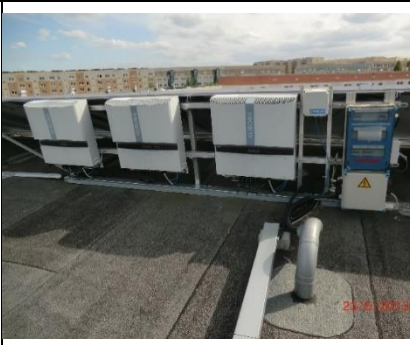
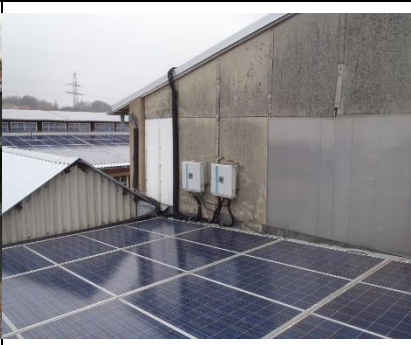
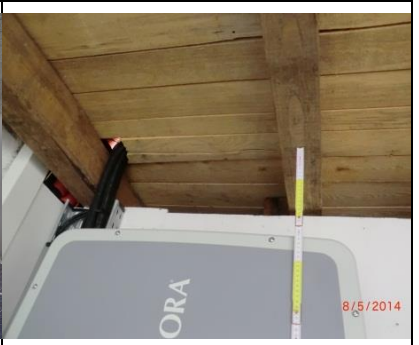
<p>Examples 1-3</p>

Component	Inverter			PVFS 4-2vs.01
Defect	Incorrect installation			
Appearance	The inverter must be installed according to the installation instruction. A common failures is the installation near flammable, explosive, corrosive or humid sources. Also the minimum distances to bottom, top or to the sides are not always fulfilled. If the input cables are not fixed properly, increased temperatures can occur at the loose contact point which lead to lower performance or risk of fire. Inverters must always be accessible for operation and maintenance and properly secured to an appropriate base.			
Detection	VI (MON)			
Origin	Violating instruction manual, e.g. installed nearby flammable materials as wood or in direct sun light. Minimum distance to adjacent components not maintained.			
	Production <input type="checkbox"/>	Installation <input checked="" type="checkbox"/>	Operation <input type="checkbox"/>

Impact	Incorrect installation of the inverter can cause danger to users and hazardous conditions and can result in <b>overheating</b> of the inverter. The use of the inverter in the presence of flammable vapours or gases can lead to explosions. The inverter housing can become very hot under operation. Follow the instruction to provide gaps from both sides and top for adequate cooling. Direct sunlight on the inverters must be avoided. The inverter must be safely accessible to avoid accidents during maintenance work.			
	Safety:

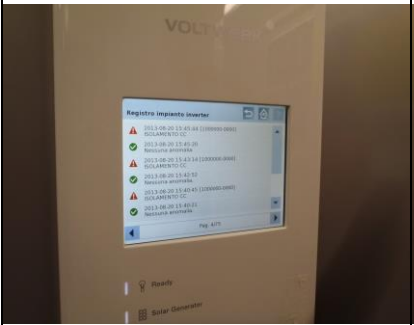
Examples  
1-3

Insulation failure. [TUV Rheinland]

Action	Corrective actions	Preventive actions (recommended)	Preventive actions (optional)	
	Restart the inverter. Replace the components with defect or abnormal temperature. Update the software.	Use IRT and VOC to check the components and connection to find poor connection or defect components.

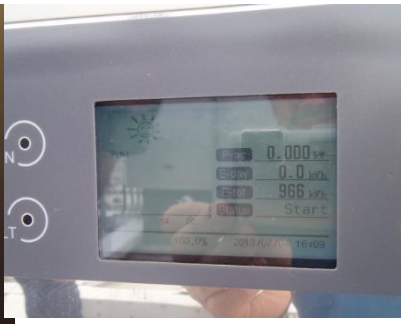
Not operating inverter. [TUV Rheinland]

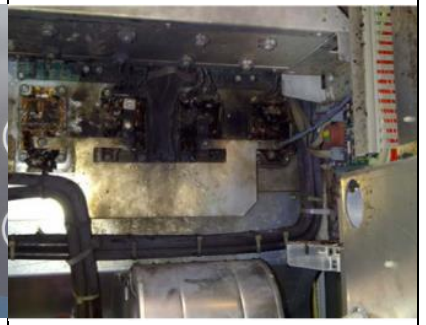
Damaged hardware component. [37]
